TRANSMITTAL

COPIES	NUMBER	DESCRIPTION	CODE
1		FRP Fabrication NCR 7-1	H

Brookfield BRF FLBR (2)

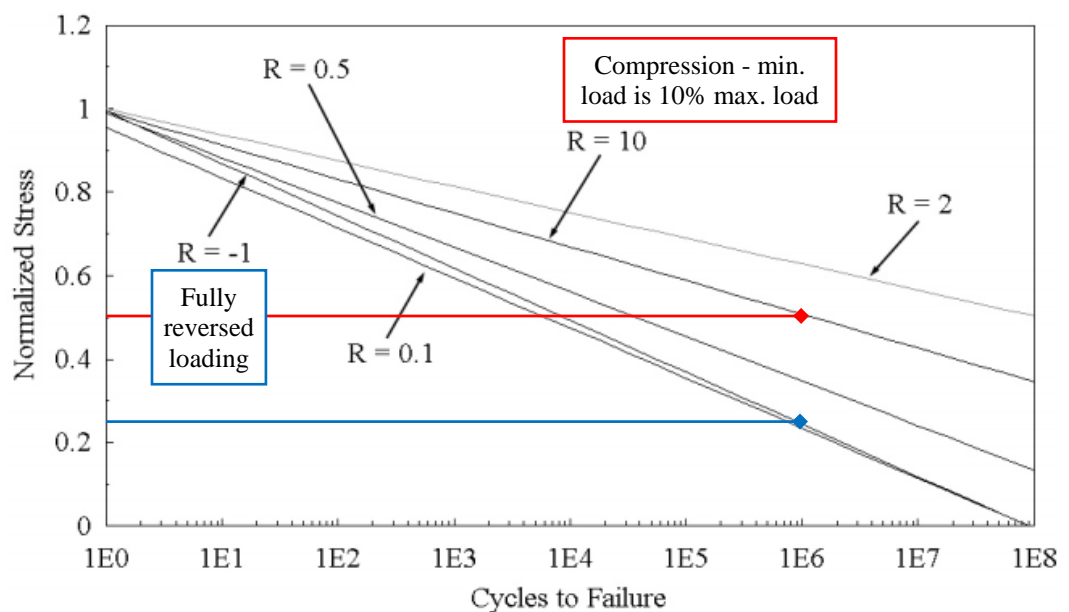
Figure 1 – Constant Amplitude S-N Fatigue Data¹

In order to empirically evaluate the long term effect of cyclic loading on the durability of the re-infusion, the direction and magnitude of applicable loads must first be defined. After reviewing the design, Kenway has determined that the quantifiable cyclic loads imparted on the repair areas will be due to ice loading where the load is one sided (compression only) or service loads where the load is fully reversed (tension and compression). Figure 1 shows curve fits to data for vinyl ester infused fiberglass specimens that have been exposed to fatigue loading. This shows that the laminate can be exposed to 50% of its ultimate compressive strength ($R = 10$) and 25% of its ultimate tensile strength ($R = -1$) and still reach 1 million cycles before failure. By comparison, the primary laminate in way of defects – completely ignoring the secondary infusion – will see 7% of the ultimate tensile strength and 2% of the ultimate shear strength.

- Quantifiable quasi-static stresses on the primary infused laminate – ignoring the secondary infusion completely – are well below the allowable design strengths as documented above.
- Quantifiable cyclical stresses on the primary laminate – ignoring the secondary infusion completely – and the anticipated number of cycles in service are orders of magnitude lower than documented S-N curves for vinyl ester/fiberglass laminate.
